Fatality #8 – September 7, 2011
Explosives - Alaska – Gold Ore
Coeur Alaska Inc - Kensington

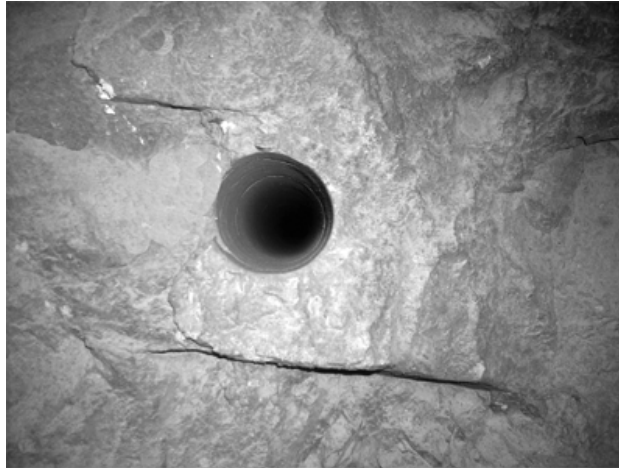
METAL/NONMETAL MINE FATALITY -On September 7, 2011, a 30 year-old miner with 1 year of experience was killed at an underground gold mine. The victim was on a ramp waiting for a blast to be initiated. When the round was initiated, small rock and debris traveled through a 3-inch diameter diamond borehole, striking him.

- Plug a diamond drill hole that intersects any opening and map the hole.
- During blasting operations, consider mine specific conditions, including diamond drill holes and rock strata, and establish mine policies and procedures to protect all persons.

- When developing a blasting plan, make sure all drilled holes and open passageways that intersect the area to be blasted are known and taken into consideration before initiating any blast.
